# ASBESTOS AND LEAD SURVEY AND HAZARDOUS MATERIALS SURVEY RESULTS

Liu Property  
Salem, Oregon

DOCUMENT  
CS10312

February 10, 1997

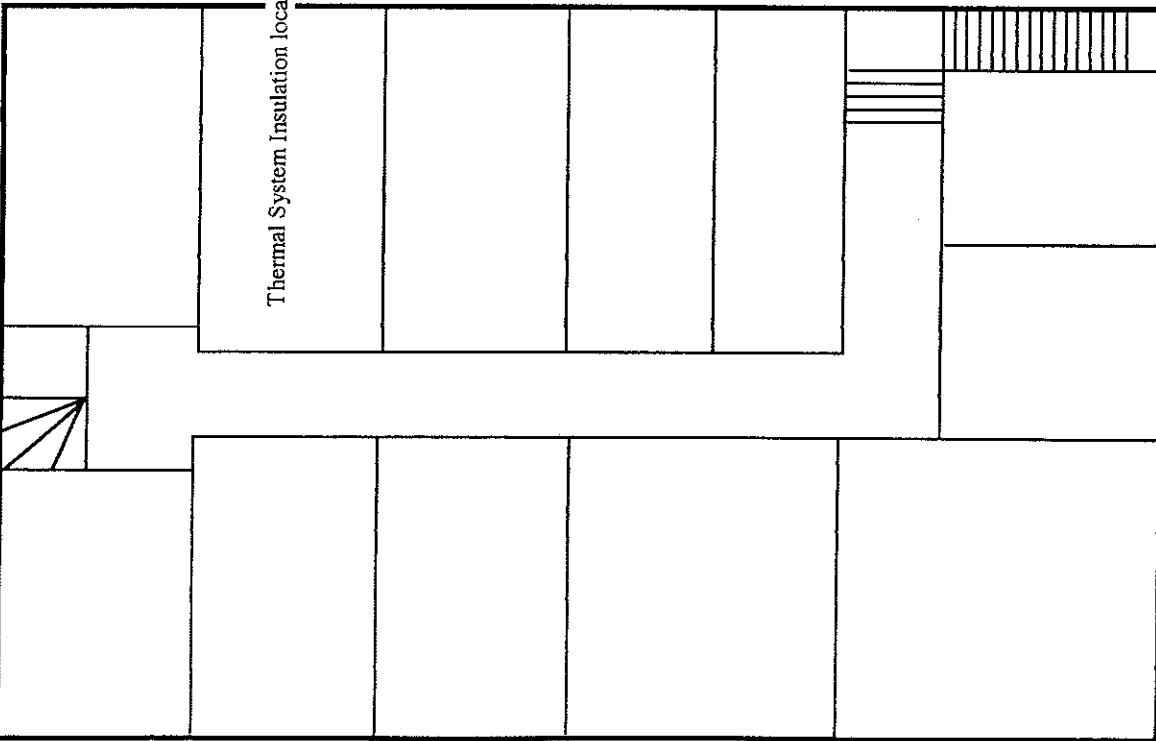
Thermal System Insulation located in attic, walls and in floors throughout building

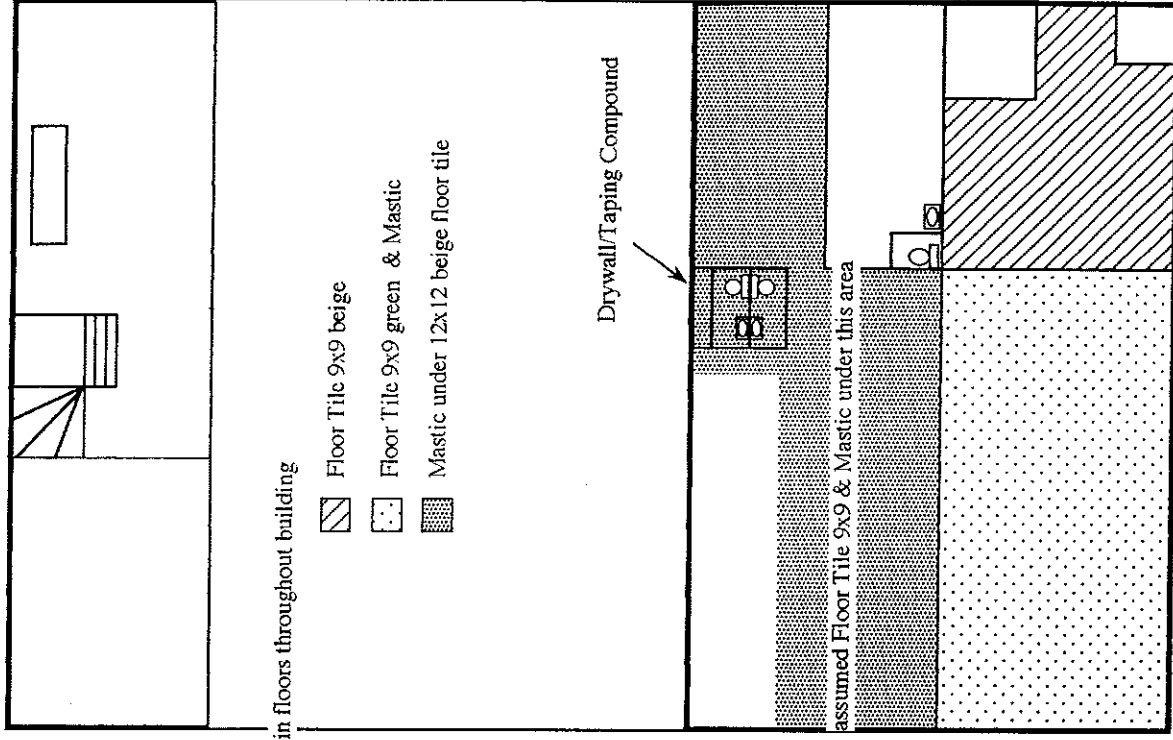
**ASBESTOS LOCATIONS**  
**DIAGRAM**

Floor Tile 9x9 beige
-

Floor Tile 9x9 green & Mastic
-

Mastic under 12x12 beige floor tile

Drywall/Taping Compound

assumed Floor Tile 9x9 & Mastic under this area

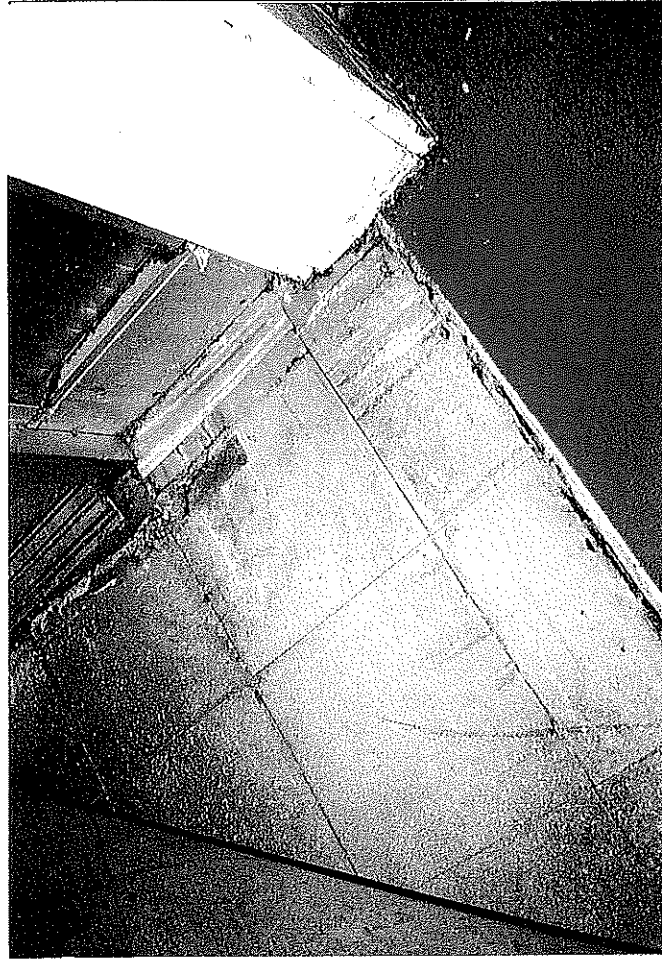
Picture No. 16

Description: Floor Tile 9x9 green, which contains approximately 20% chrysotile asbestos.  
Locations: Throughout S. section of the Liquor Store and assumed to be under the 12x12 beige floor tile in the N. section.  
Quantity: Approximately: 1,428 sq. ft.

Description: Mastic under green 9x9 floor tile, which contains approximately 15% chrysotile asbestos.  
Locations: Throughout S. section of the Liquor Store and assumed to be under the 12x12 beige floor tile in the N. section.  
Quantity: Approximately: 1,428 sq. ft.

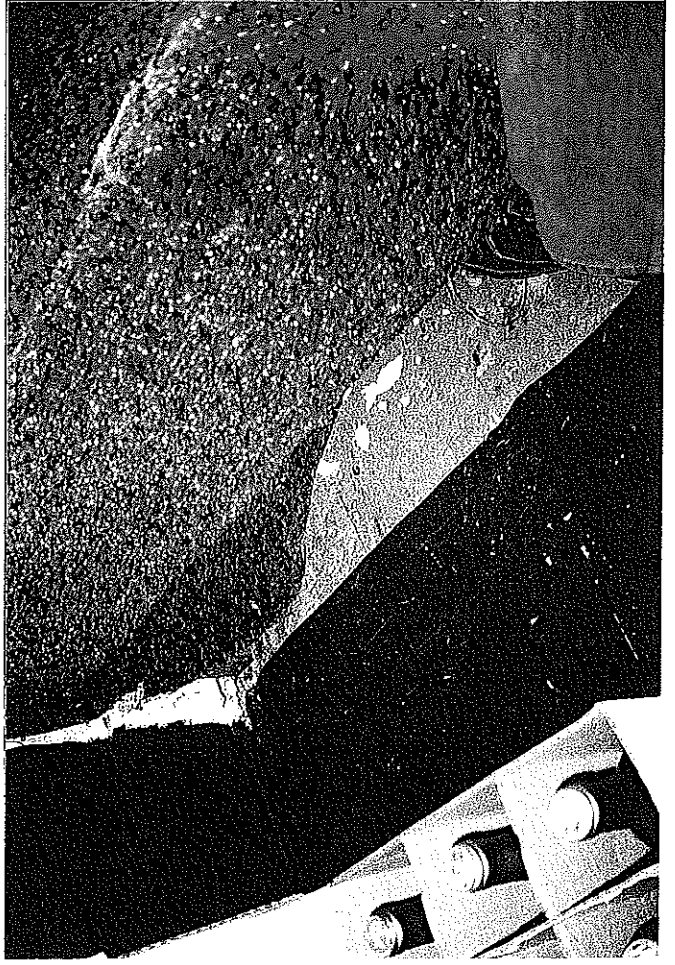
Picture No. 23

Description: Floor tile 9x9 beige, which contains approximately 10% chrysotile asbestos.  
Locations: Throughout S. room of the Wine Shop  
Quantity: Approximately: 600 sq. ft.
