Bldg:CS Record: 10311
Project ID: CS9701)
Phase I Environmental Assessment

**PHASE I
ENVIRONMENTAL SITE ASSESSMENT
Marion County Property
Tax Lots 100, 200, 600, 700, 6300, 6400, 6500, and 6600
Salem, Oregon 97301**

February 4, 1997

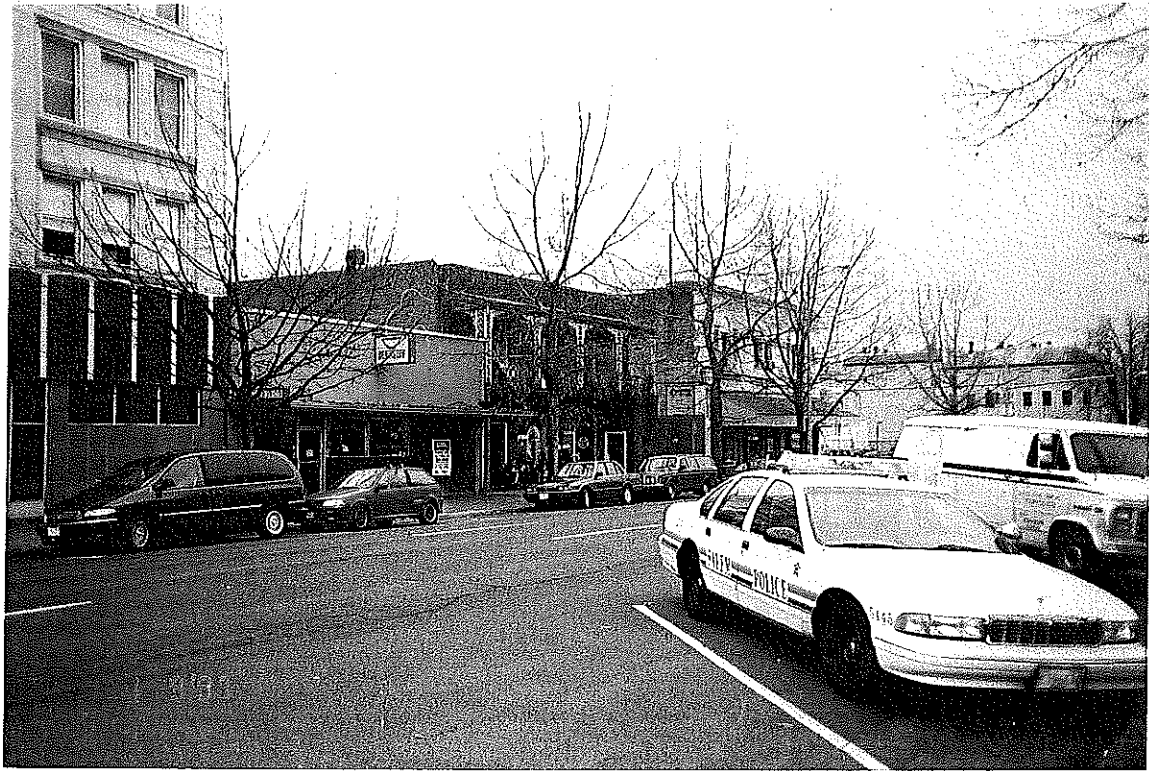
Photograph 1. The Goodman, Goldberg, and Liu properties on Court Street.

The structure on the Goodman property is occupied by the Court Street Dental Clinic, a dental care facility (Photograph 1). The east-west alleyway located on the north side of the building is an easement included in the Goodman property tax lot. The premises have been used as a dental facility for approximately 50 years. Prior to use as a dental facility, the subject site was occupied by a title company. The clinic occupies all of the building and between one-third and one-half of the ground floor in the northwest section of the Goldberg property building, adjacent to the east. The clinic includes a waiting room/reception area, examination rooms, offices, x-ray room, laboratories, darkroom, kitchen/break room, record storage vault, laundry room, furnace room, storage room, and an unoccupied storage building. An approximately 200-gallon aboveground storage tank (AST) located in the parking area to the north of the building currently provides oil for the furnace. No staining or sheen was observed under the AST. The condition of a heating oil UST formerly located in the alley is not known.

Adjacent to the east of the Goodman site is the Goldberg property, a two-story building which is fully developed with law offices and a retail storefront coffee house (Photograph 1). Adjacent to the east of the Courtway building is a north-south trending alley. In the alley near the northeast corner of the Courtway building is a circular concrete manhole-type cover in the asphalt pavement (Photograph 2). This feature may be a sump or septic tank. An unregistered UST may have been

On the east side of the alley is a two-story building (Alex Liu property) with two retail spaces housing a liquor store and a wine store on the ground floor and twelve apartments on the second floor (Photograph 1). Based on the findings of a previous site investigation at the Liu property, there is a heating oil UST located under the floor of the furnace room at this site.

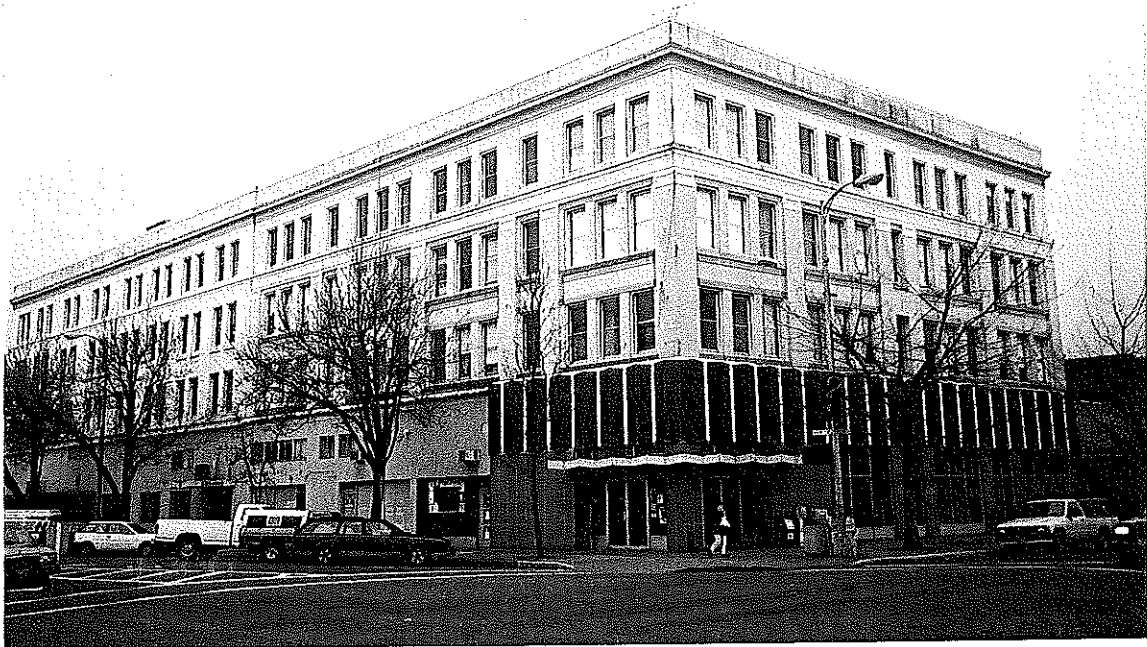
Photograph 3. The Senator Hotel (southwest corner).

The four-story Hotel Senator building, which was built in 1927, occupies most of the southwest corner and west-center portions of the block (Photograph 3). The street level of the hotel building is either vacant or occupied by storefront retail businesses, including the Mar Po Federal Credit Union in the southwest corner of the building. Until early January 1997, the second, third, and fourth floors of the portion of the hotel located in the southwest corner of the property (Tax Lot 700) consisted of apartments. Marion County rented the apartments to people on public assistance (Photograph 4). The west-central portion of the Hotel building (Tax Lots 600 and 6400) is occupied by Marion County offices and the Marion County Housing Authority (Photograph 5). Most of the basement of the building is used for storage by the county (Photograph 6). Three air-conditioning units are located on the roof of the building.

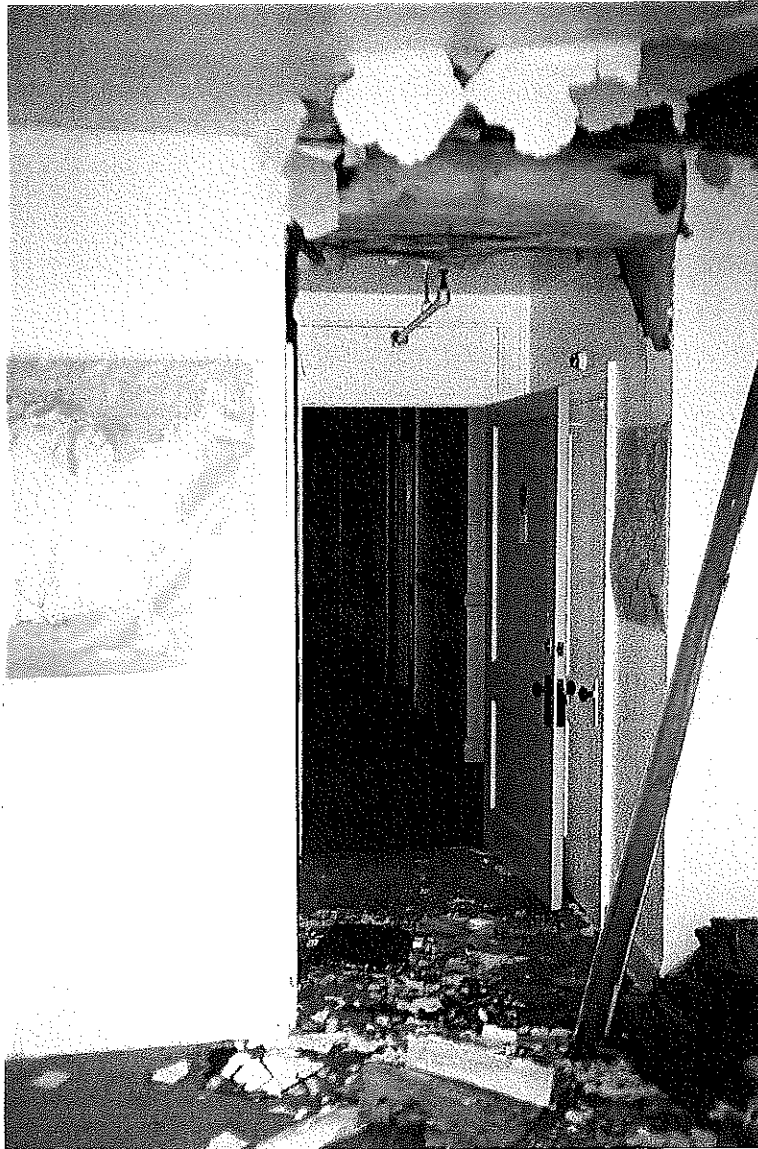
Photograph 4.

A vacant apartment in the southwest portion of the hotel building.

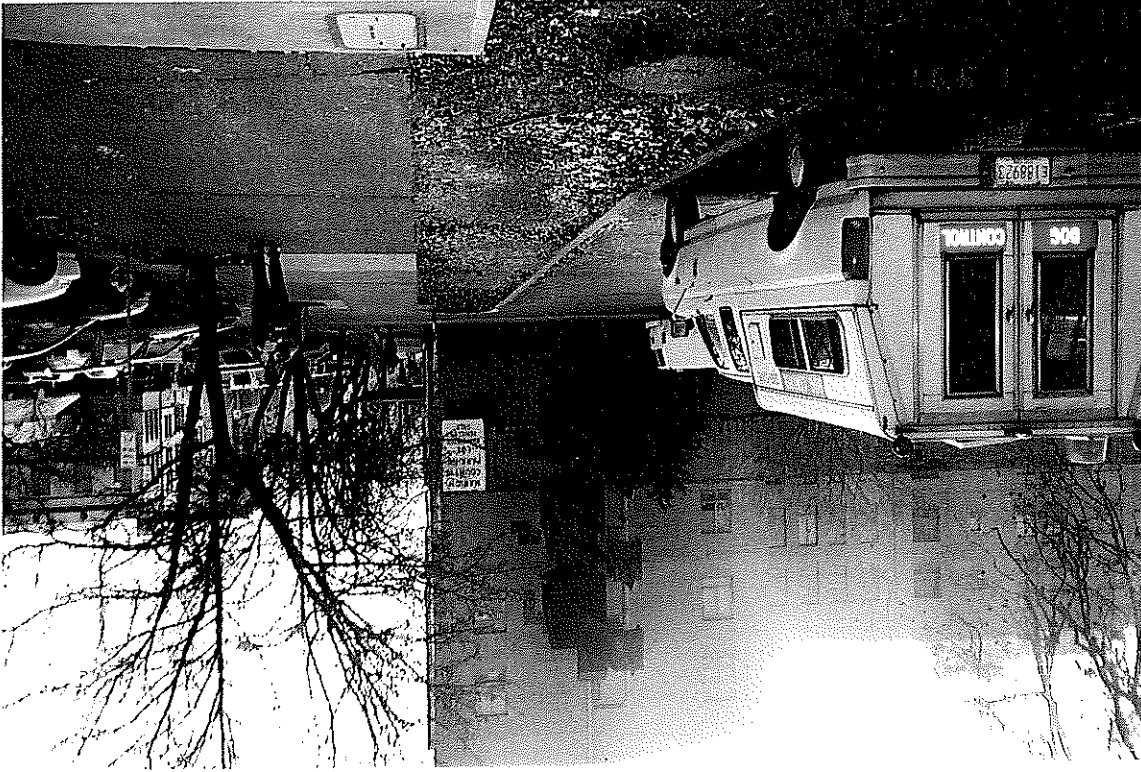
Photograph 9.
The parking lot on the northwest corner of the subject property.

A Marion County parking lot occupies the northwest one-quarter of the city block (Photographs 9 and 10). This portion of the property was formerly used by a service station, auto repair business, tractor sales, a restaurant, and for battery repairs. The service station was located on the corner of the block from 1926 through 1961. The location of the USTs at the station was not
