# ASBESTOS AND LEAD SURVEY AND HAZARDOUS MATERIALS SURVEY RESULTS

Liu Property  
Salem, Oregon

DOCUMENT  
CS10312

February 10, 1997

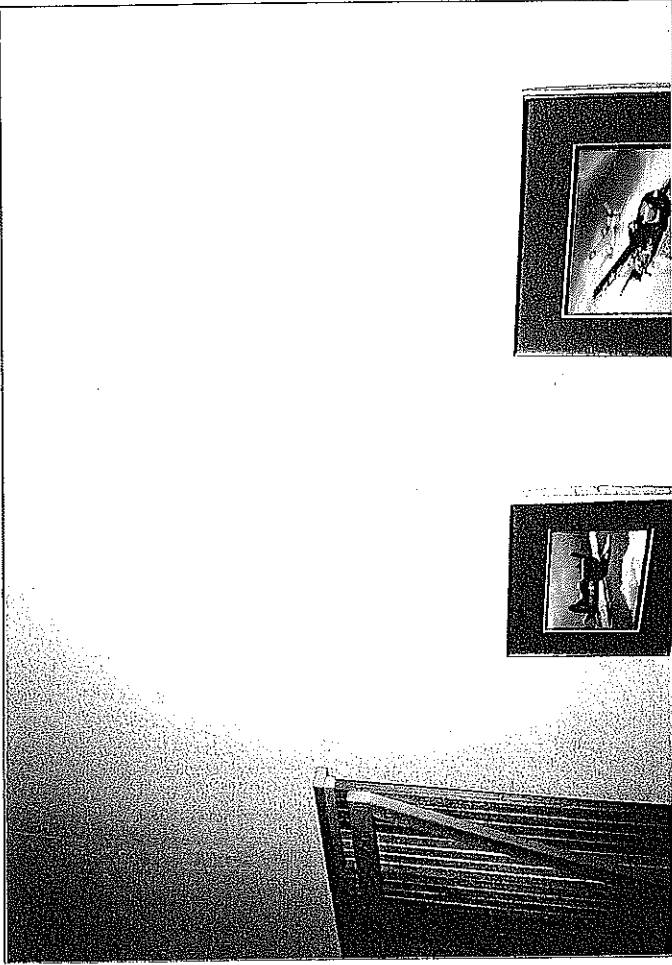
Picture No. 26

Sample #	Material Description	Sample Location	Photo #	Asbestos %
WN-13	Drywall/Taping Compound	North Wall	26	0%
WN-14	Drywall/Taping Compound	North Wall	26	0%
WN-15	Drywall/Taping Compound	North Wall	26	0%
WN-16	Plaster, lath & plaster	North Wall	27	0%
WN-17	Plaster, lath & plaster	North Wall	27	0%
WN-18	Plaster, lath & plaster	North Wall	27	0%
	Thermal System Insulation	Throughout Building	N/A	Assumed
APT=	Apartments			
LR=	Liquor Store			
WN=	Wine Shop
